OPERATION CASTLE

Project 3.5

BLAST EFFECTS ON MISCELLANEOUS STRUCTURES

REPORT TO THE SCIENTIFIC DIRECTOR

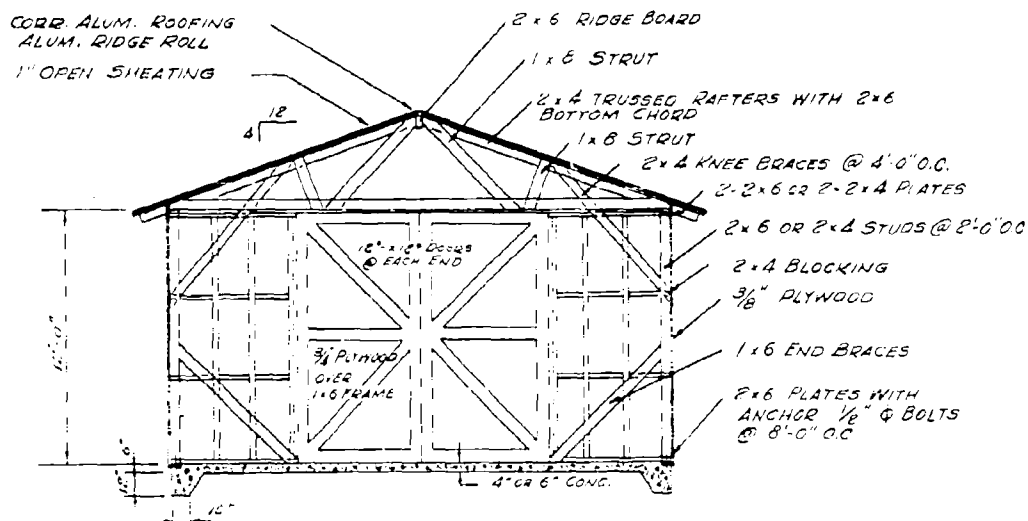
Fig. 2.1 Typical Warehouse Section, Tare Island, 14-3/4 Miles from GZ

The shops and warehouses were light frame buildings similar to those previously described. Figure 2.1 is a typical section of a warehouse.

All the warehouses on Tare Island suffered severe damage. However, the shop buildings (Bldgs 19 and 20, Fig. 2.1) came through the blast with light damage even though the design of these buildings was similar. This is seen best by studying Fig. 3.1. No explanation is offered for this marked difference in degree of damage to similar structures in the same area. Figures 3.23 - 3.25 are views of the Holmes and Narver bin storage warehouse. Figures 3.26 - 3.28 show different views of the

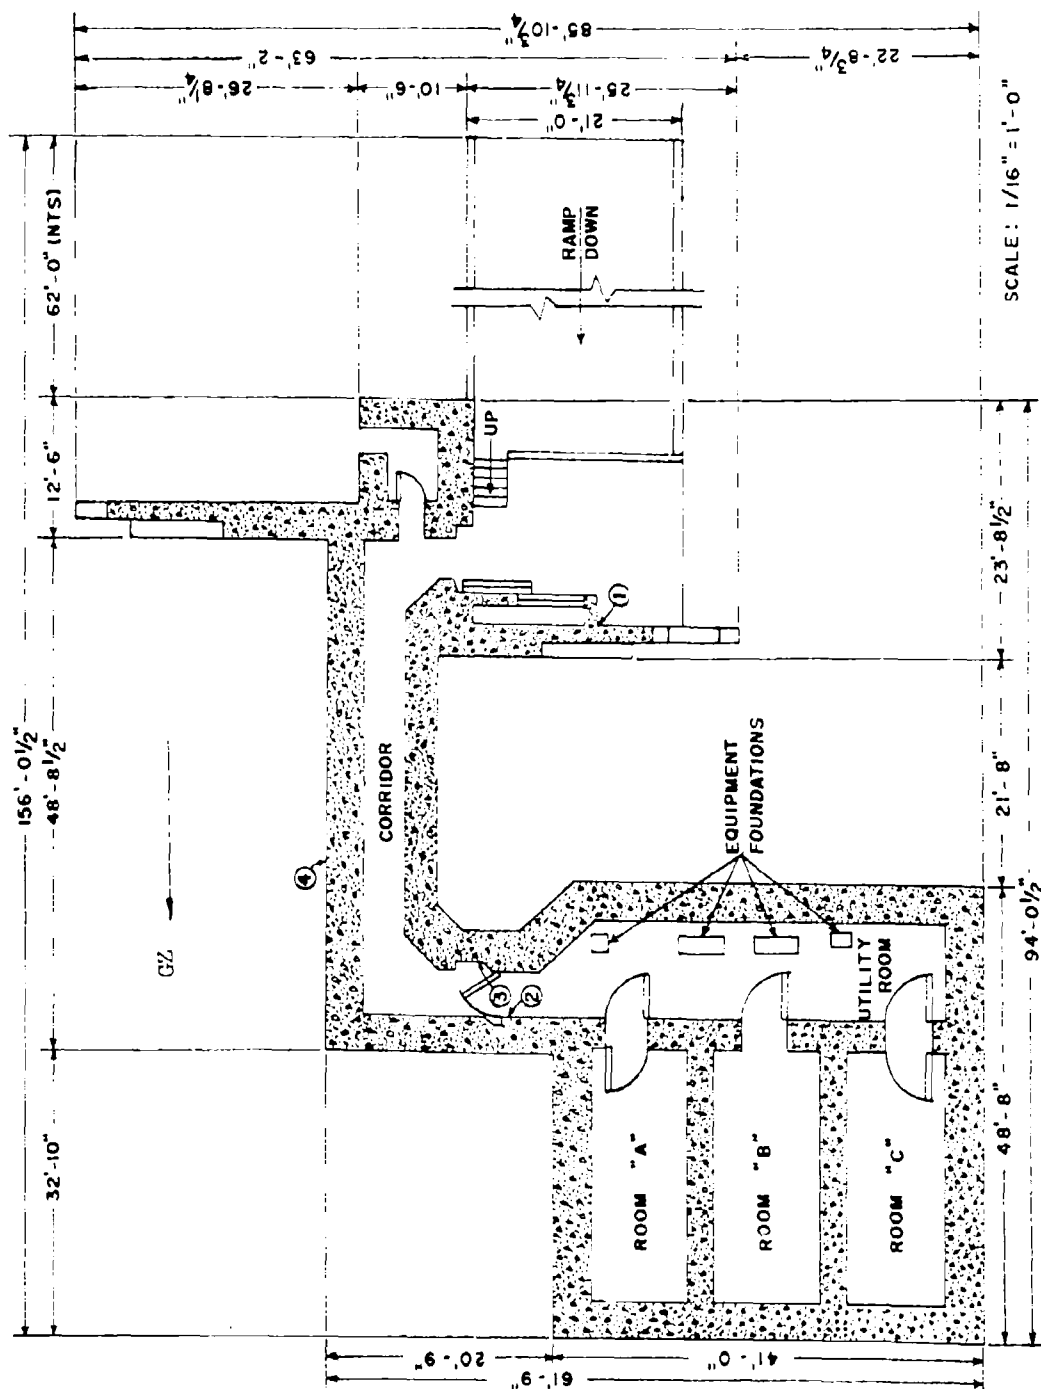
Fig. 2.7 Floor Plan, Station 1200, Charlie Island, 7565 ft from GZ

Station 1200 was a reinforced coral concrete earth-covered instrument shelter located about 7565 ft northeast of ground zero. Figure 2.7 is a plan view of this station. This station was designed by approximately the same criteria as Station 1341.

The failures which occurred to the reinforced concrete walls were at the structural discontinuities and the retaining walls. Figures 3.52 and 3.53 are exterior views of the front and rear of Station 1200. Portions of the parapet and retaining walls at the rear of the structure were torn off by the blast. Figure 3.54 shows extensive cracking of the retaining wall at position No. 1 in Fig. 2.7. Figure 3.55 is a view of a corridor wall near the doorway at positions No. 2 and No. 3 respectively as shown in Fig. 2.7. These cracks and a crack in the corridor wall and ceiling at position No. 4 in Fig. 2.7 were the only major structural failures inside the building.

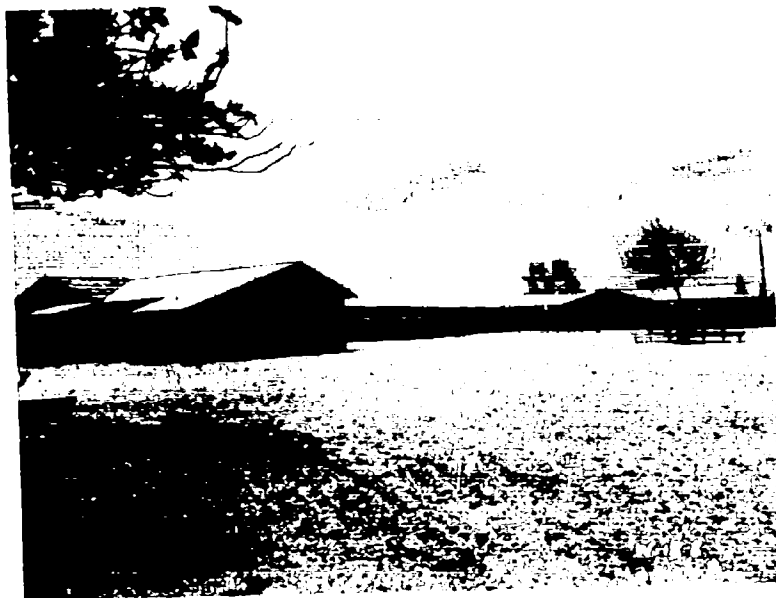
Fig. 3.12 North Side of Mess Hall Before Installation of North Wing, Tare Island, Preshot

Figures 3.12 and 3.13 are pre- and postshot views of the north dining wing of the mess hall which most nearly faced ground zero. Most of the side was caved in and the rafters were badly damaged. Figures 3.14 and 3.15 are pre- and postshot views of the south dining wing. The entire side and large sections of the roof were blown out. One 16' x 40' section of roof was hurled a distance of 75 feet from its original location. Other views of interest are Figs. 3.2 and 3.16 - 3.19.
